Environmental Monitoring Report

Project Number: 44458-013

Reporting period: January - June 2023
December 2023

Uzbekistan: Amu Bukhara Irrigation System Rehabilitation Project

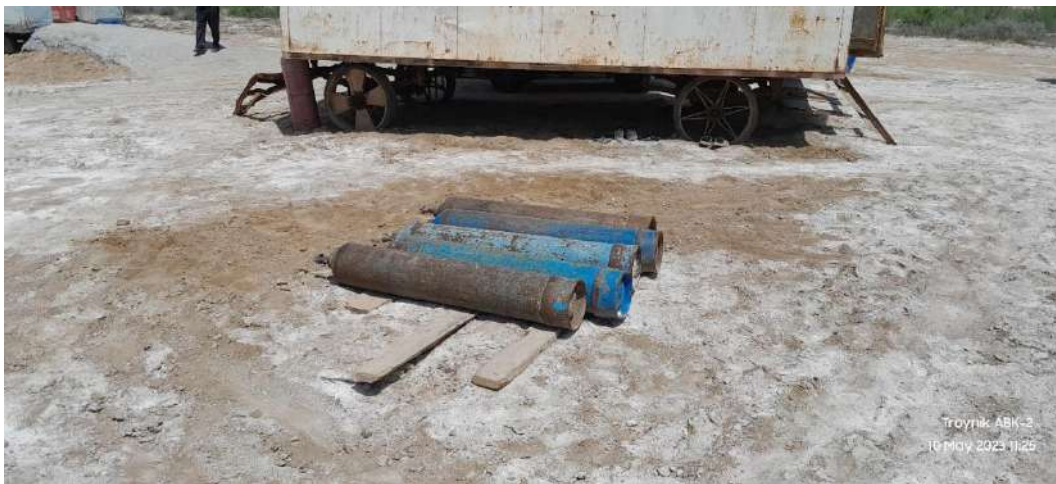
Photo 1: Oxygen cylinders

42. CSC observed that all full and empty oxygen cylinders are left around recklessly. Especially full cylinders should be protected from exposure to direct sunlight, should be stored in a dry and shady area in an upright position. During transportation and use, a special trolley should be in use and all cylinders should be chained against overturning. Cylinder should not be touched with oily hand or gloves. CSC reminded the ABISRP 02 Contractor to take necessary actions and be sensitive to these warnings. Please see Photo 1 below.

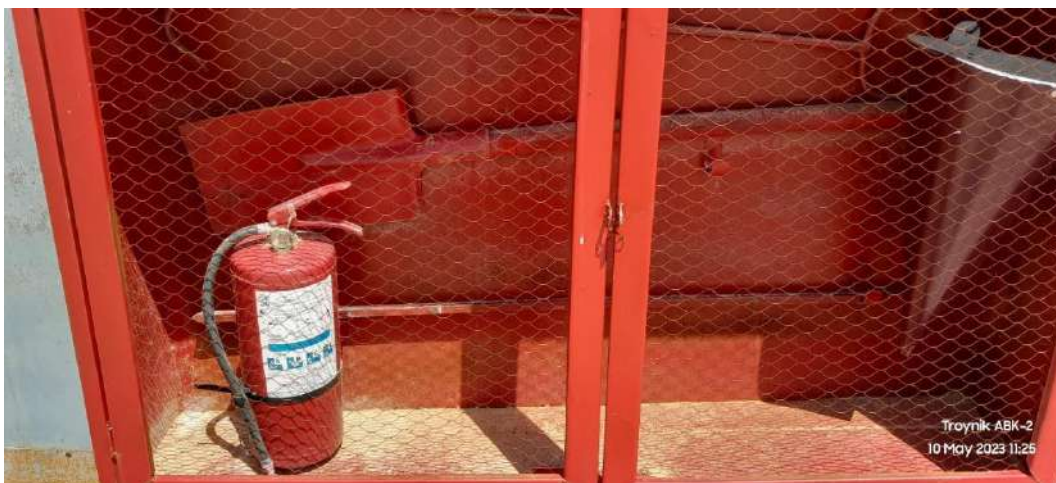
Photo 2: Locked fire cabinet

43. CSC observed and reminded the ABISRP 02 Contractor that fire cabinets are kept locked. All workers should be able to reach these fire extinguishers immediately in case of fire. This is why, these cabinets should be easily accessible, with no lock on it, or obstacle in front of that. All fire extinguishers should be maintained regularly by competent third party. Please see Photo 2 below.

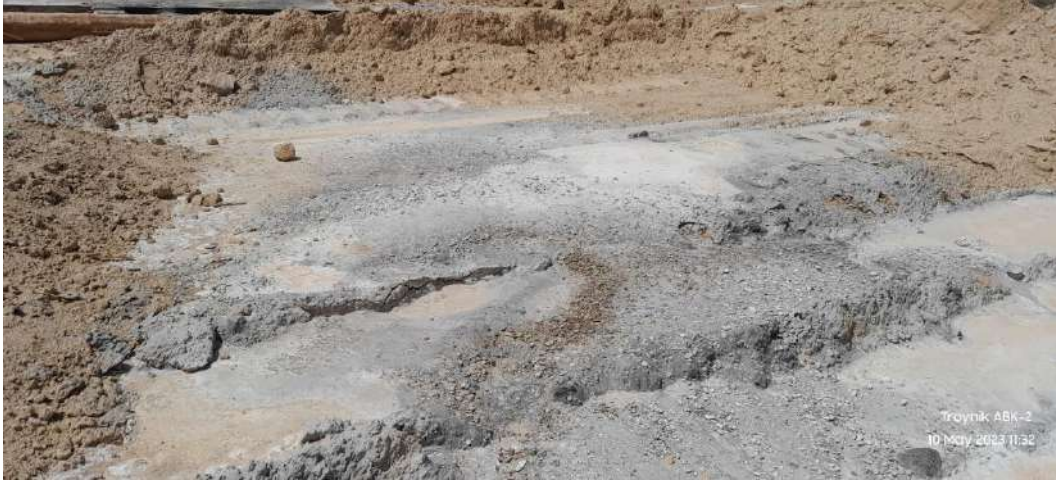
Photo 3: Concrete waste on the ground

44. CSC observed and reminded the ABISRP 02 Contractor that concrete wastes are dumped on the ground. Concrete waste should not be dumped on the ground. It should be cleaned from the ground immediately and transferred to waste dumping area of related municipality. Please see Photo 3 and Photo 4

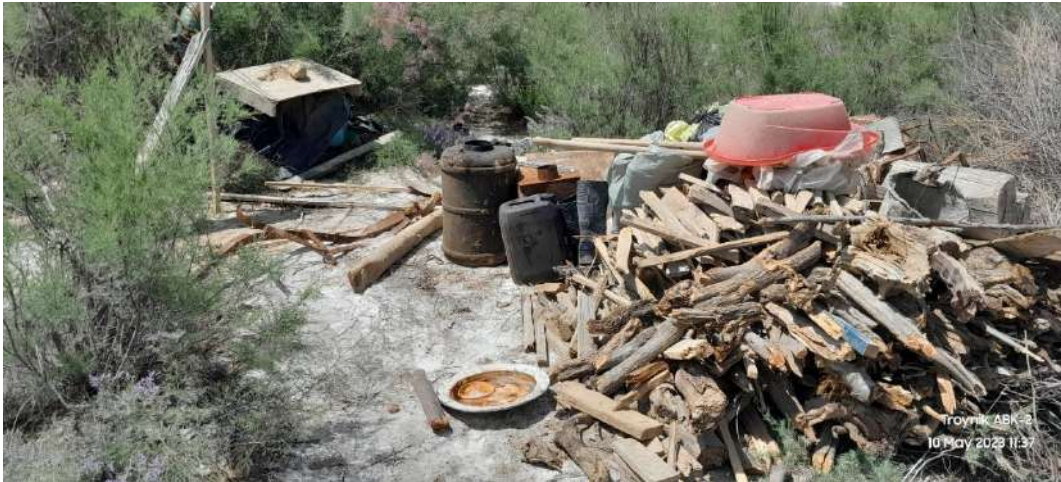
Photo 5: Domestic wastes

45. CSC observed and reminded the ABISRP 02 Contractor that domestic wastes are kept at site on the ground directly. The contractor should establish a temporary waste storage area, ground of which is impermeable material and store domestic wastes on that, in covered bins. Please see Photo 5.

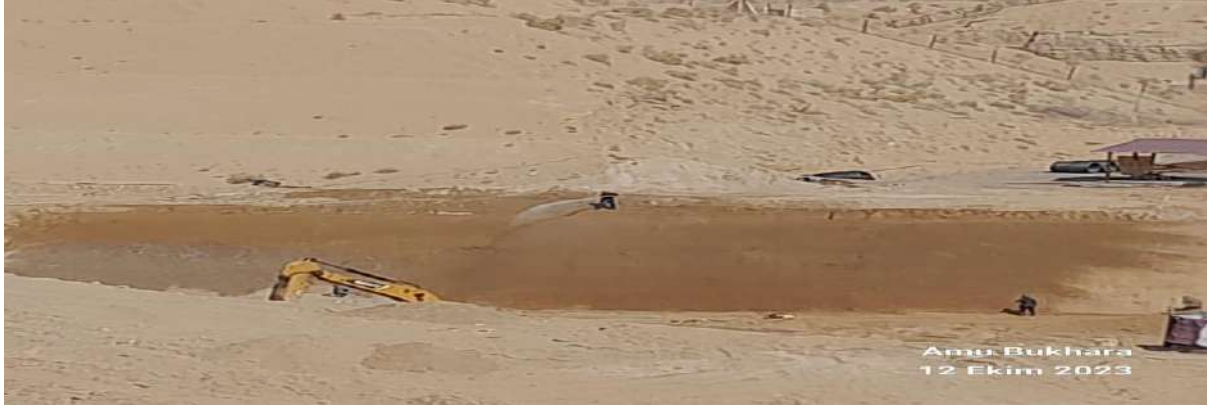
Photo 6: Water spraying

63. CSC has observed that the Contractor of AB-1 New PS (Contract ABISRP 01) sprays water, when necessary, in order to prevent dust generation. However, no matter how well they do it, completely suppressing the dust is a little bit difficult to because campsite and workplace are in the desert. Water spraying photo is presented in Photo 6 and Photo 7 below.

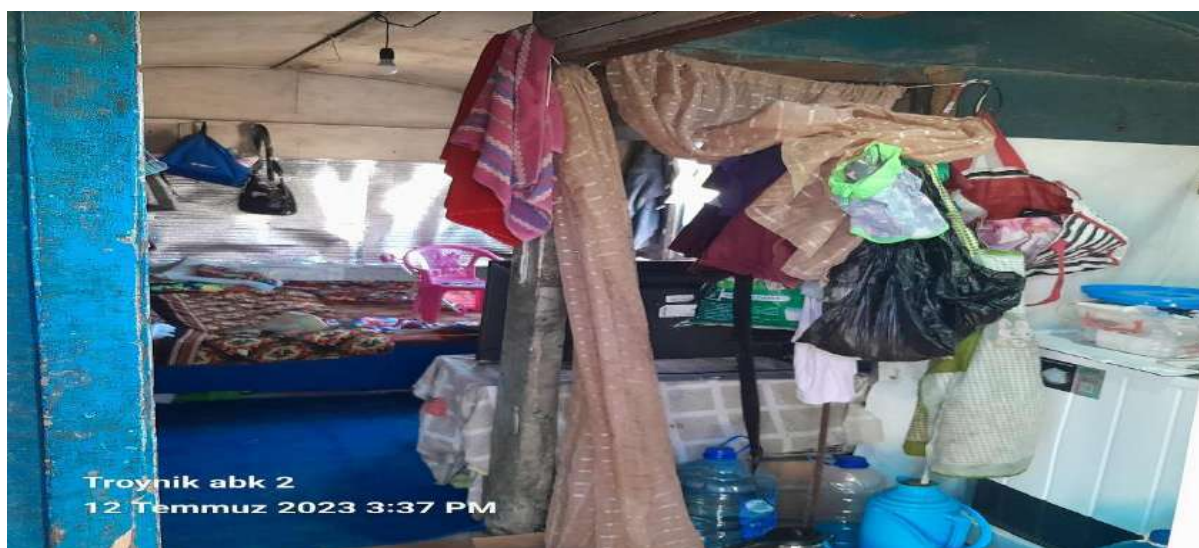
Photo 8: Accommodation facility of family

109. CSC observed that there is a worker within the organization of Kogon Suv Kurilish, who resides at site continuously together with his family (his wife and his little daughter) in very poor accommodation conditions. When CSC Environmental safeguard interviewed with this staff, he declared that, he has stayed at site all day (24 hours) with his family in these conditions which signify a very old 3 meters x 7 meters sized container, into which they try to fix everything a family will need (Photo 8). Hygienic conditions are very bad. CSC reminded to Contractor's site manager to improve living condition of family as quickly as possible.

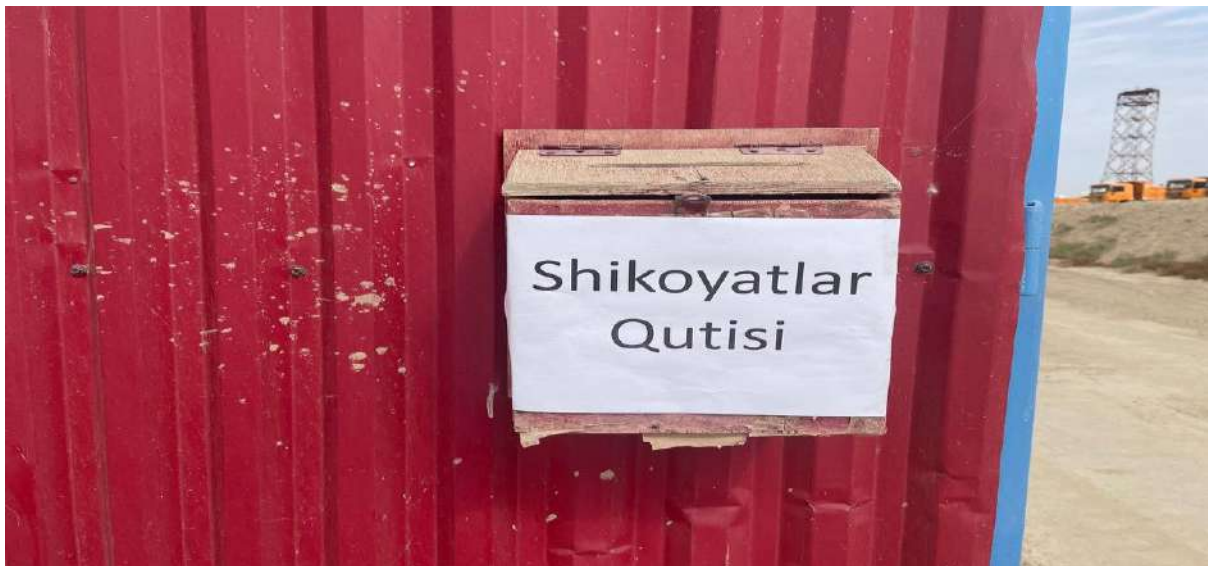
Photo 9: GRM box

128. The contractor CNTIC (ABISRP 01) has established a GRM box (Photo 9) at the entrance of camp site, into which any complainant will be able to put his complaint letter if it arises. As mentioned in previous sections too, the workplace is in the middle of desert so there is not any settlement area in which there will be local people who will possibly be affected from the project implementation. Because of these reasons, there is not any complaint received as of the beginning of the project. CSC reminded the contractor to increase number of GRM boxes throughout the camp site and workplaces and enlarge its size to be more prominent.

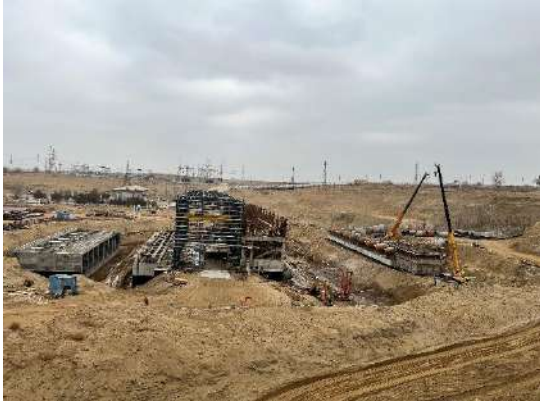
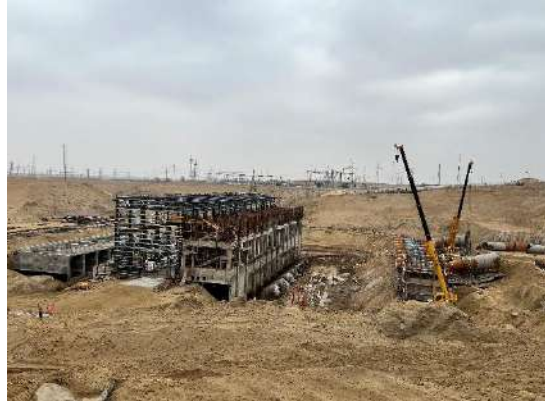
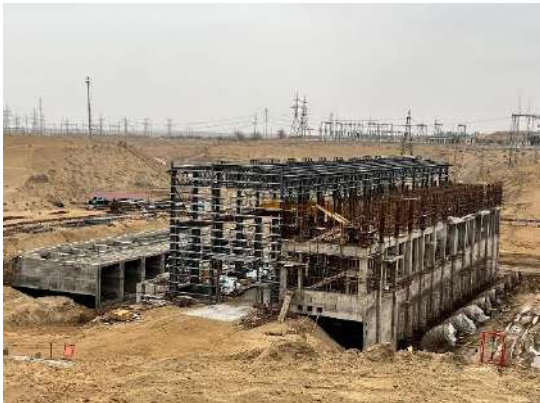
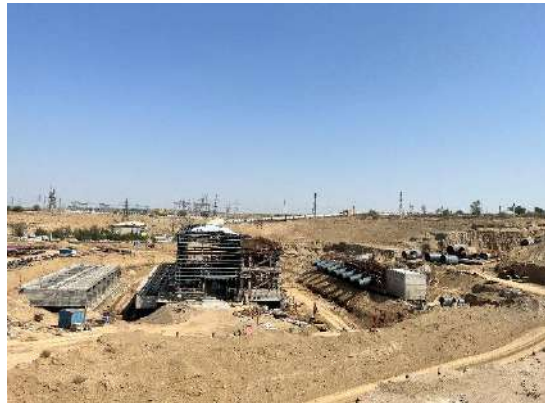
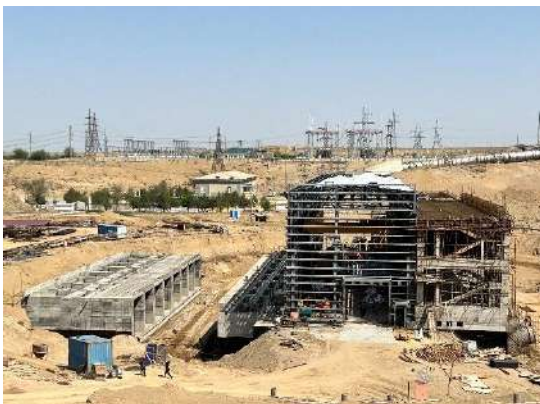
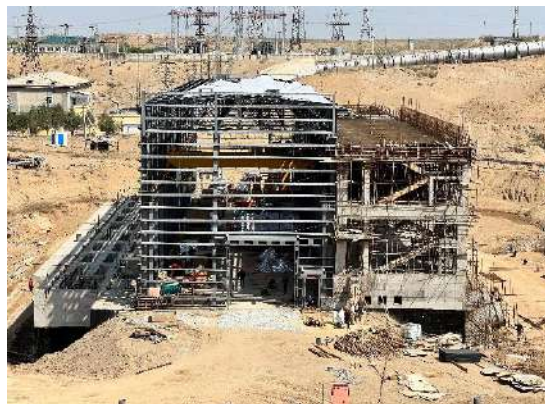
General View of the Pump Station Building and Construction of the Auxiliary Building Behind the Pump House (ABISRP 01)

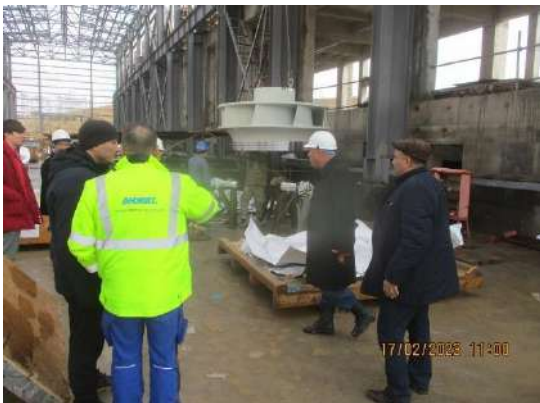
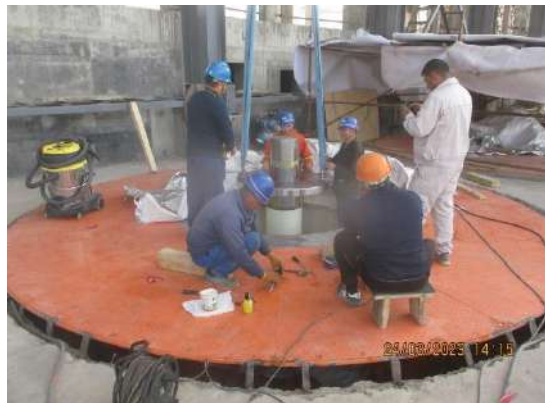
Installation of Main Pump Units (ABISRP 01)

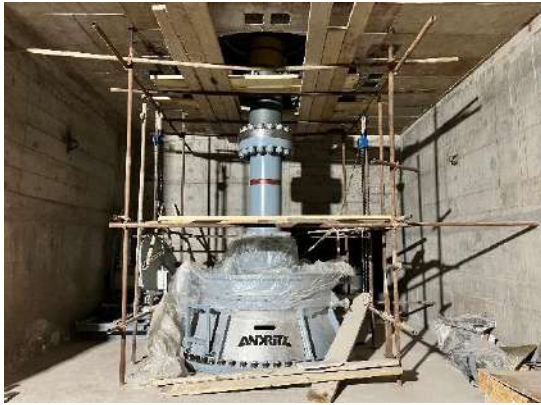
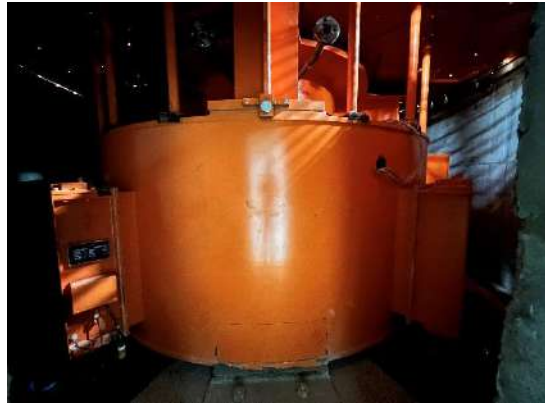
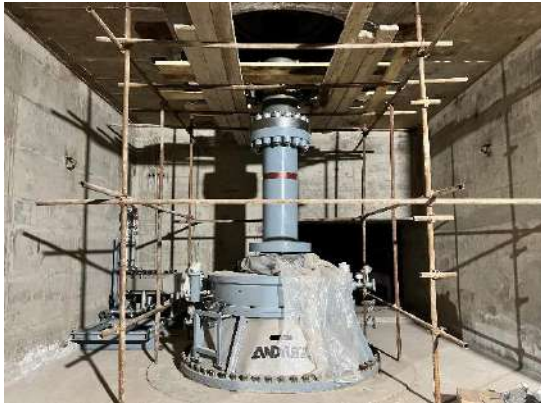
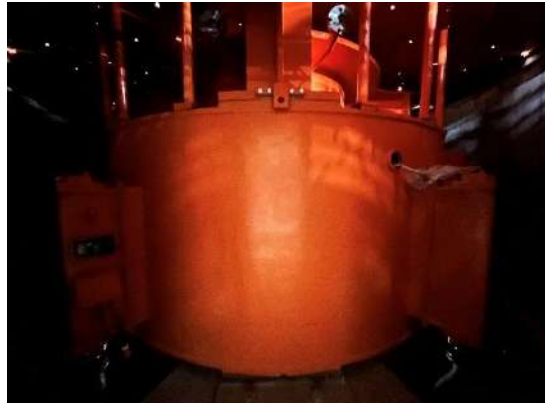
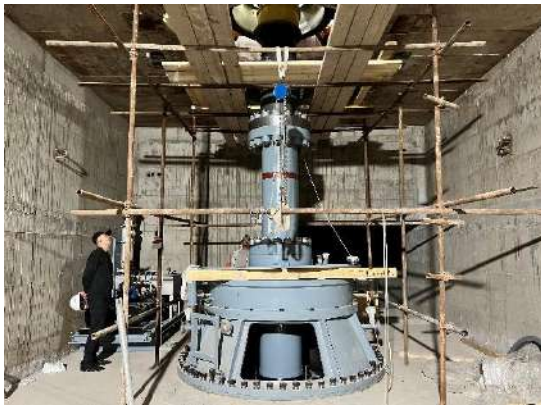
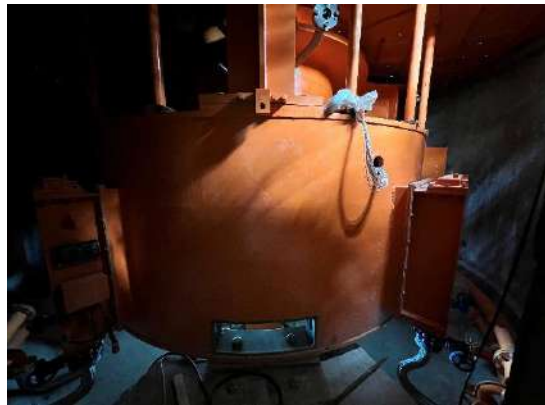
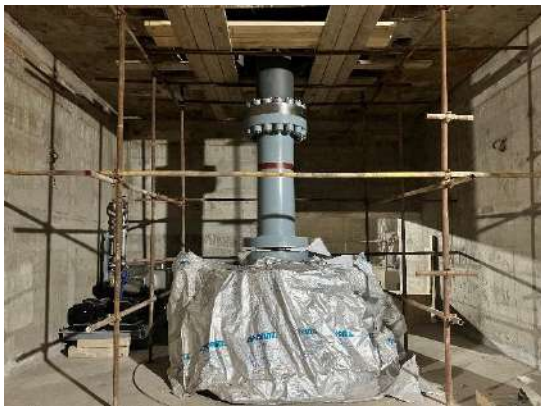
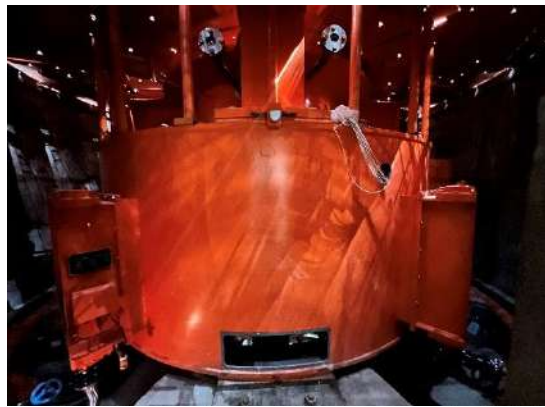
Installation of Main Pump Units #5, 6, 7 and 8 (ABISRP 01)

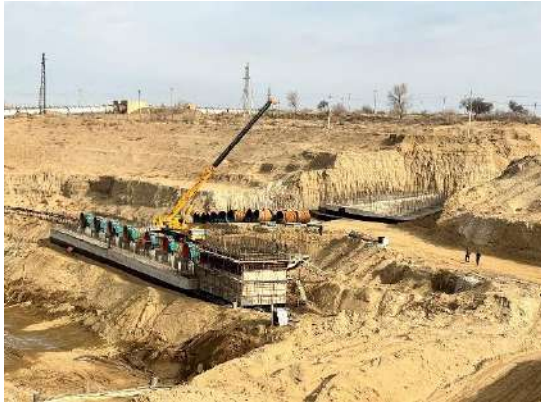
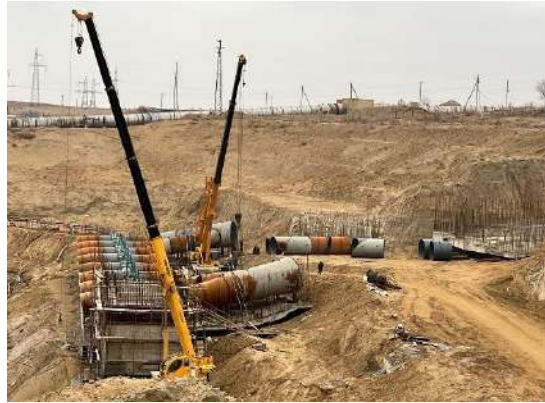
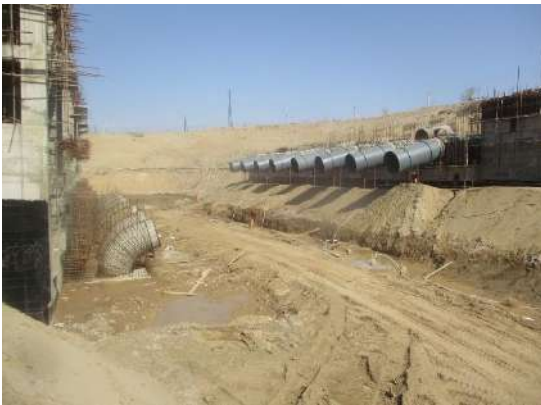
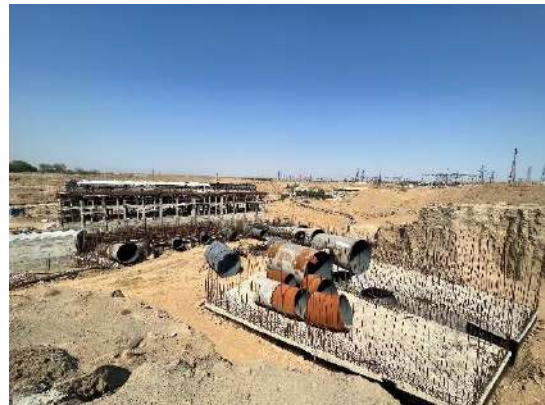
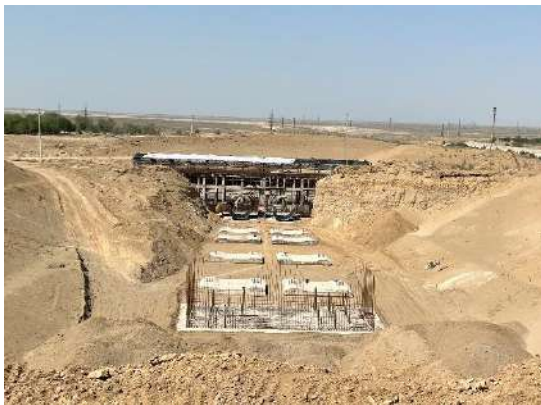
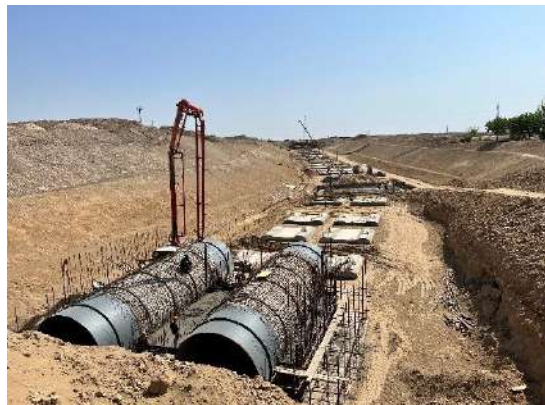
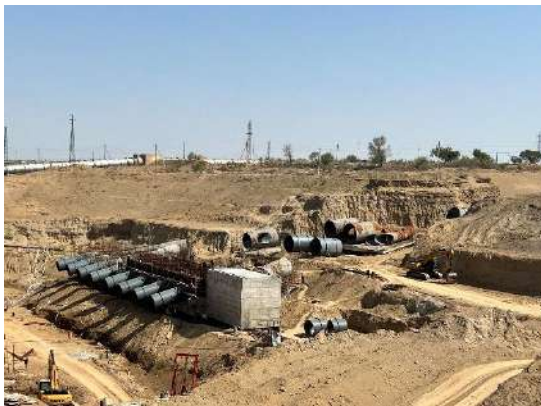
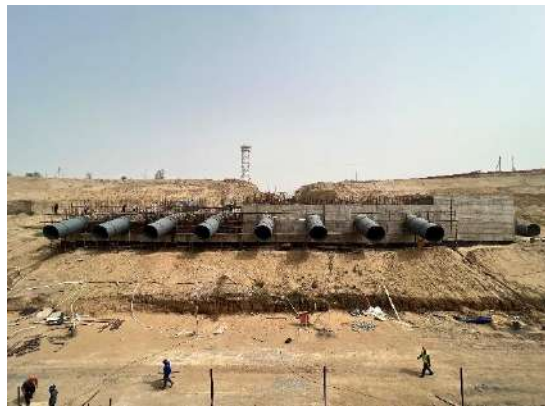
Construction of the Maintenance Butterfly Valve Chamber and Installation of the Maintenance Butterfly Valves and the Discharge Pipeline (ABISRP 01)

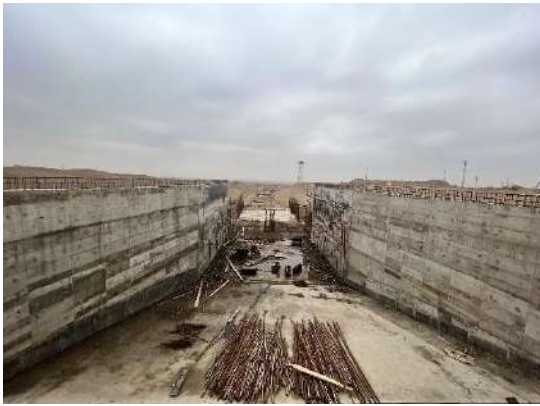
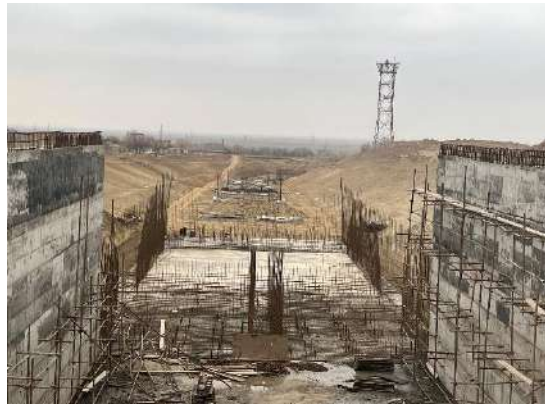
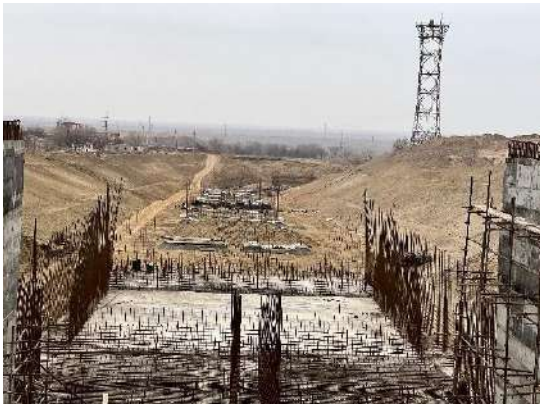
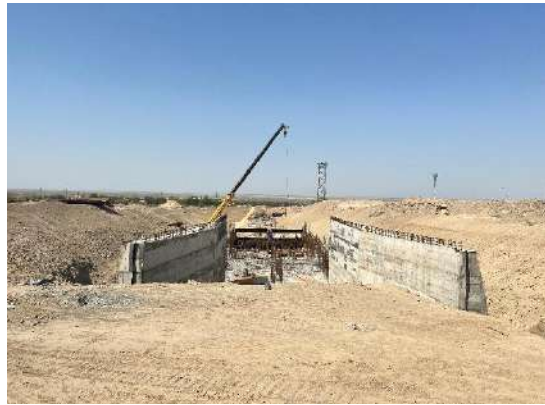
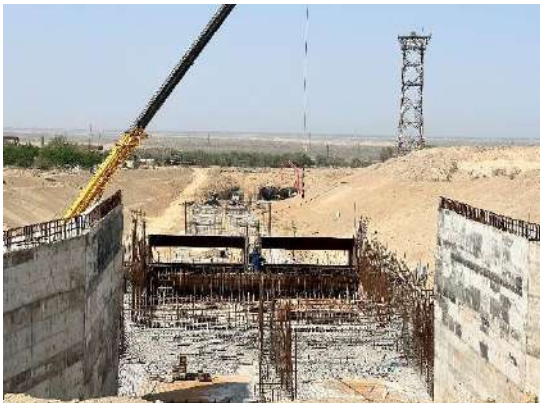
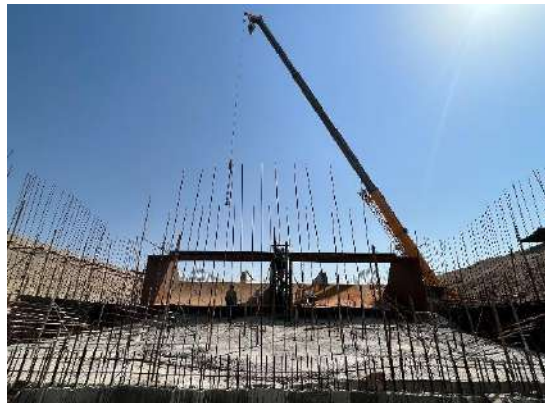
**Construction of the Outlet Structure and Installation of the Steel Liner of the Syphon Structure
(ABISRP 01)**

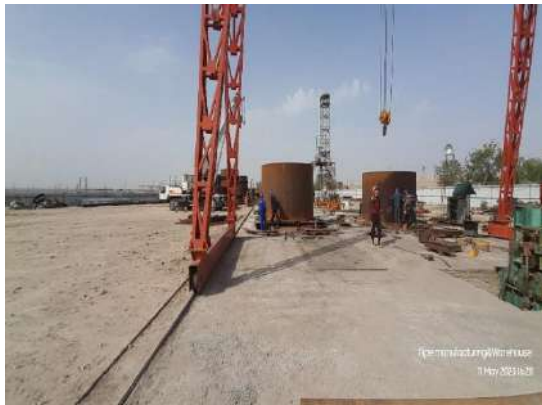
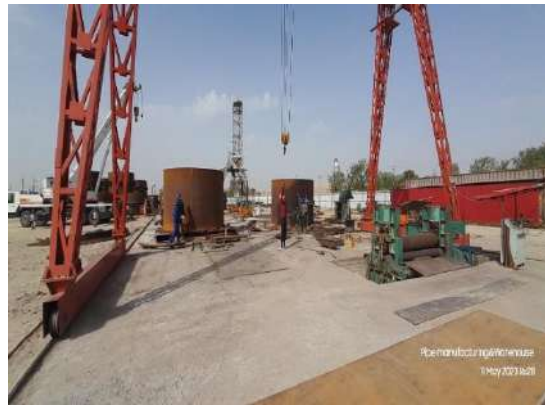
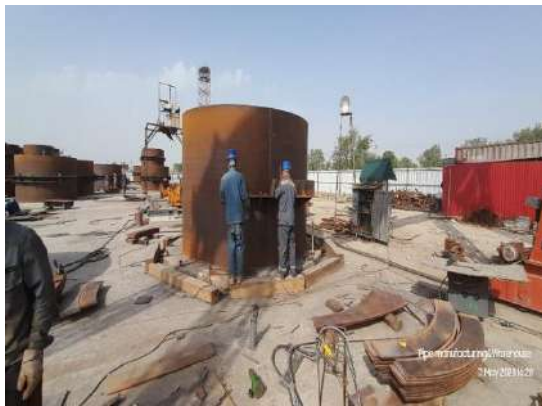
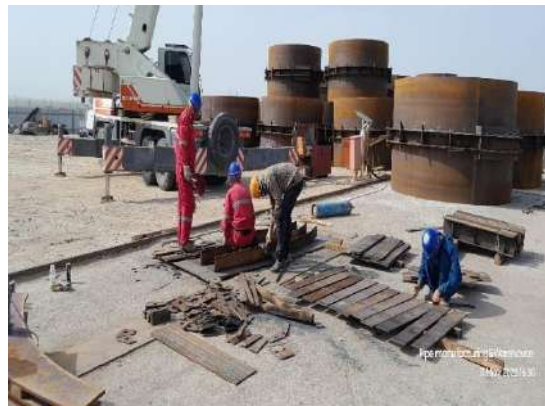
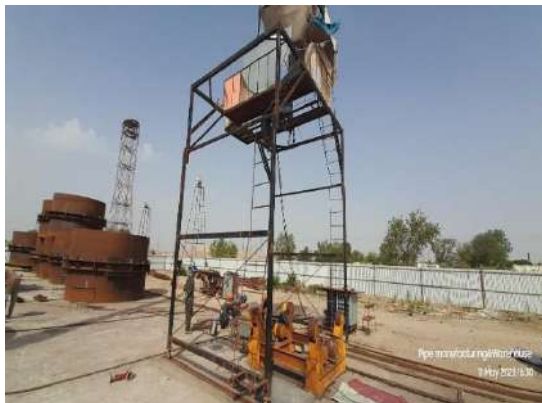
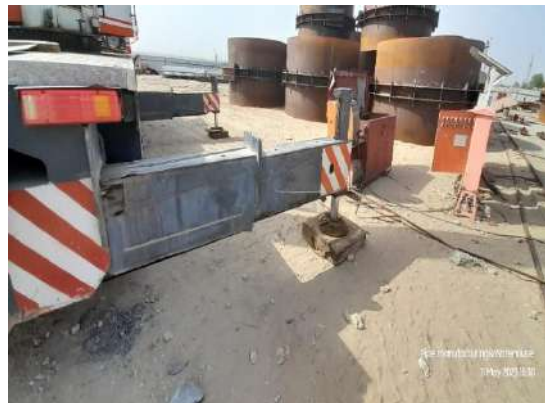
Manufacturing of Discharge Pipes at the Workshop at Site (ABISRP 01)

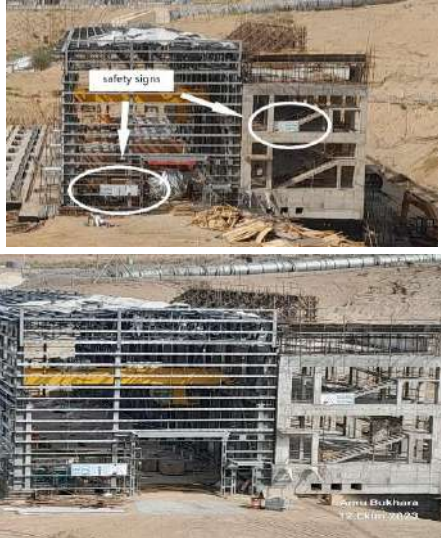
#	Findings/Notes	Action to be Taken	Responsibility	Timing (Target Dates)	Description of Resolution and Timing (Actual)	If not yet resolved, indicate the reason why and specify further required action and timeframe.
1	Specific areas like working at height, hazardous and flammable material storage areas are not indicated with signs (Photos #1-2)	Provide signages and information boards on designated areas with appropriate visuals and in a language understandable to both Uzbek and Chinese workers.	Contractor	20 May 2023

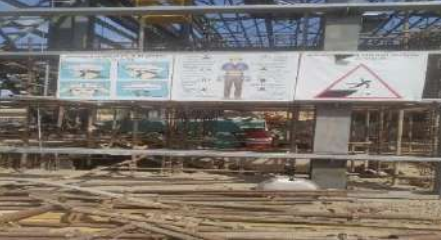
24.05.2023
2	Safety boards with instruction photos are not noticed at site	Provide/set-up occupational health and safety board's instruction photos onsite	Contractor	31 May 2023

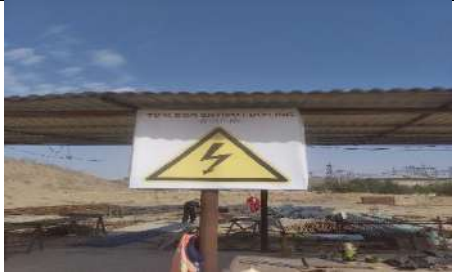
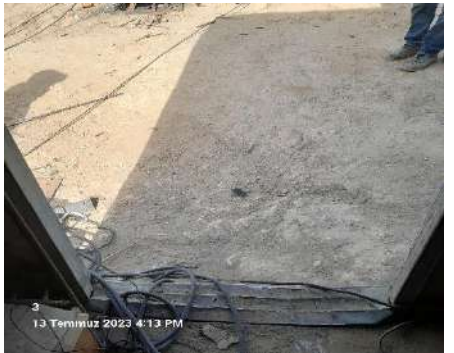
3	Wastes are scattered in some areas of the construction area. Segregation of wastes not observed in some parts of the site. (Photos #3-5)	Segregation of wastes all around the site should be done and the workers should be trained on waste management	Contractor, CSC	31 May 2023

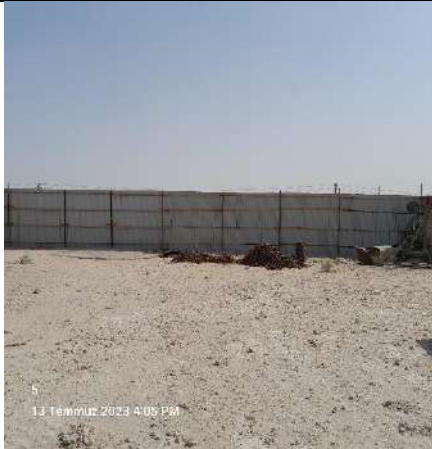
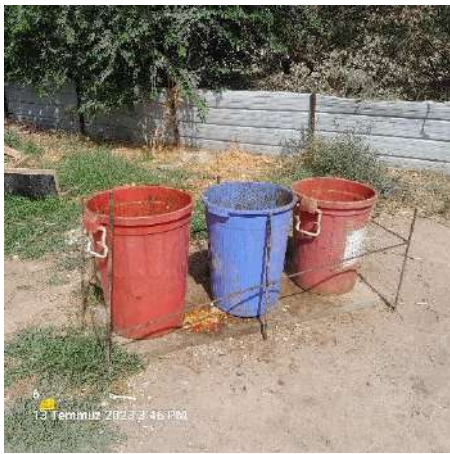
4	Waste bins near the kitchen do not have lids and are not labeled. As a result of which plastics and wet/kitchen wastes are combined and scattered by animals (cats and dogs) in the area (Photo #6)	Waste bins should have lids and labeled by type of waste. Workers should be trained on waste management	Contractor, CSC	20 May 2023

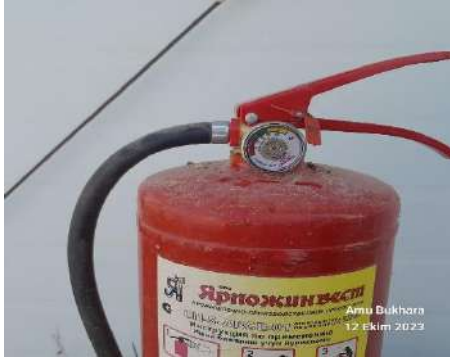
#	Findings/Notes	Action to be Taken	Responsibility	Timing (Target Dates)	Description of Resolution and Timing (Actual)	If not yet resolved, indicate the reason why and specify further required action and timeframe.
5	Most fire extinguishers not re-filled	Fire extinguishers have to be ref-filled and expiration dates checked regularly. Avoid putting them under the heat of the sun. Provide proper storage area for fire extinguishers making them visible and readily accessible.	Contractor	20 May 2023

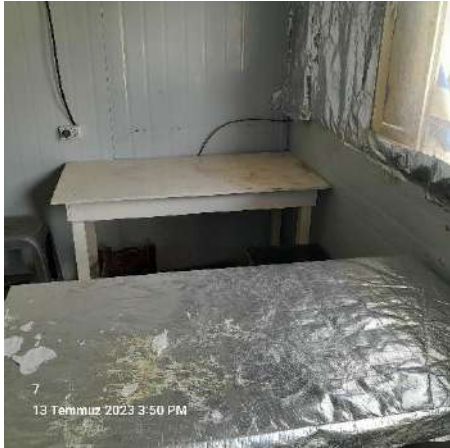
24.05.2023
6	Workers sleeping quarters are not properly ventilated. Sanitation may also be an issue since workers use the quarters for eating as well. (Photo #7)	Recommended to organise a separate dining/eating area with tables and chairs where workers can eat properly and at the same time socialize with other co-workers. The existing area near the kitchen for Uzbek workers can be used for this purpose.	Contractor	31 May 2023

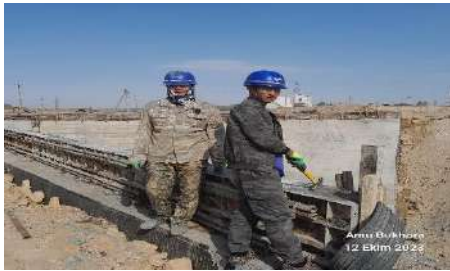
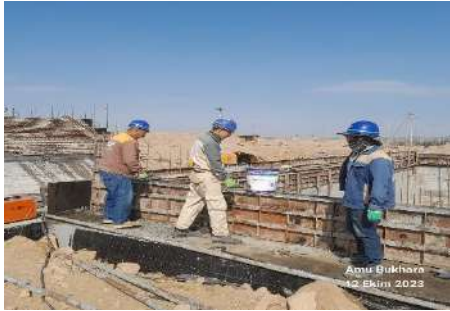
#	Findings/Notes	Action to be Taken	Responsibility	Timing (Target Dates)	Description of Resolution and Timing (Actual)	If not yet resolved, indicate the reason why and specify further required action and timeframe.
7	Some workers are working with gloves off in places where it is recommended to work with gloves and full PPE.	Ensure that all workers wear full set of PPE and provide them instruction/training on safety rules	Contractor, CSC	20 May 2023

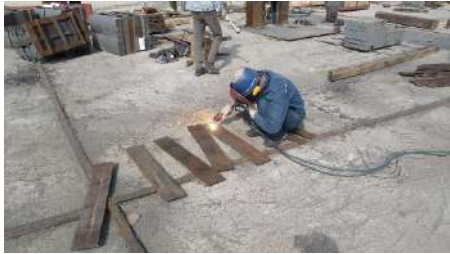
25.05.2023
8	Workers are not wearing ear sets in areas where noise level are observed to be above the norm	Provide a baseline instrumental monitoring for noise level at welding site. Attach the result in the next Semi-Annual Environmental Monitoring Report due on 15 July 2023.	Contractor, CSC	31 May 2023

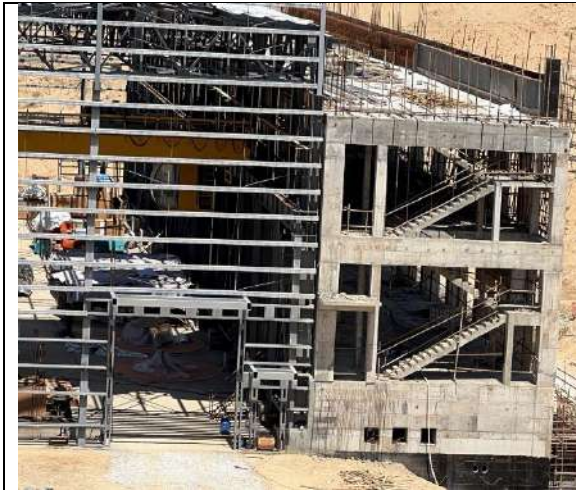
1. Construction of pumping station. Working at height without safety signs and instruction/boards.

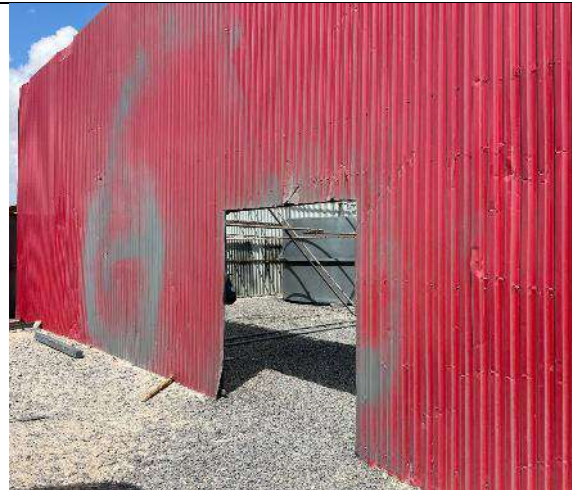
2. Hazardous and flammable material storage area without signs

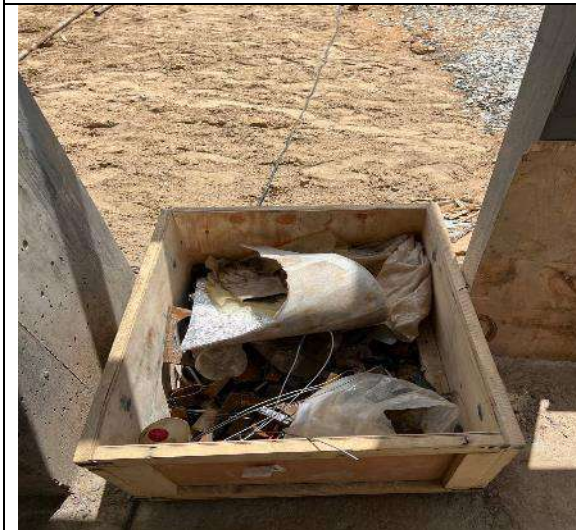
3. Construction materials and other wastes not segregated.

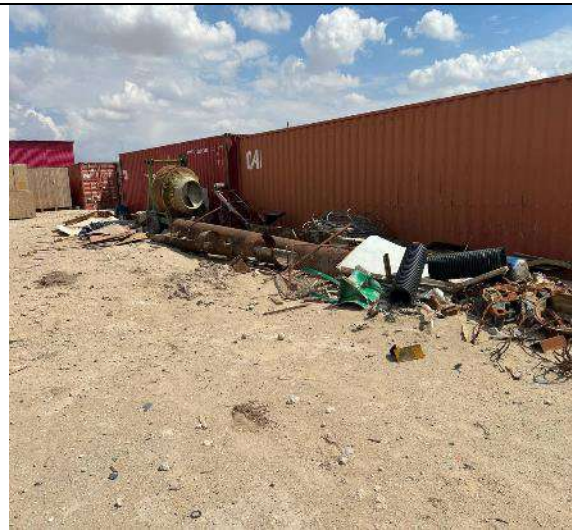
4. Different kind of wastes and construction materials not segregated.

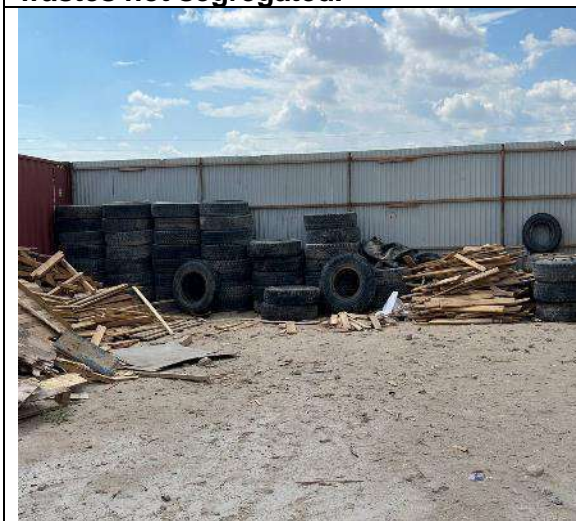
5. Different kind of waste and construction materials not segregated.

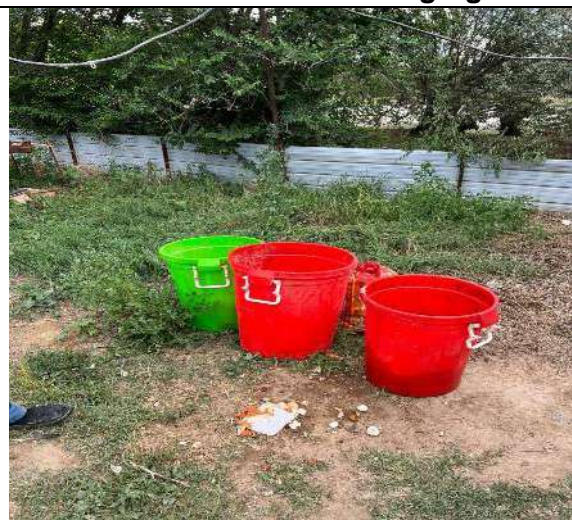
6. Kitchen wastes in bins without lids and labels.

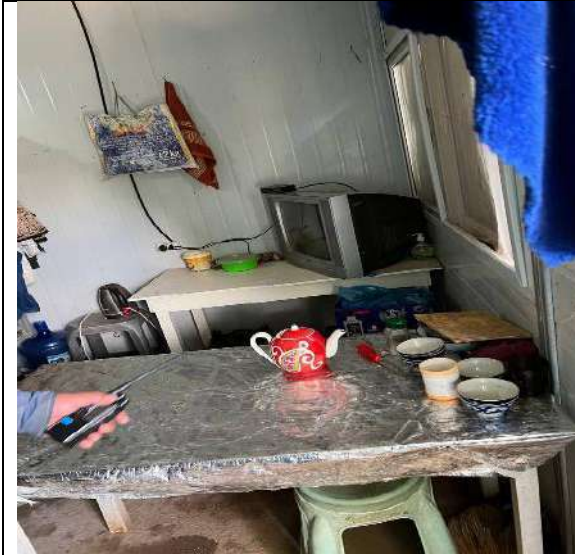
7. Quarters' sanitation condition is an issue

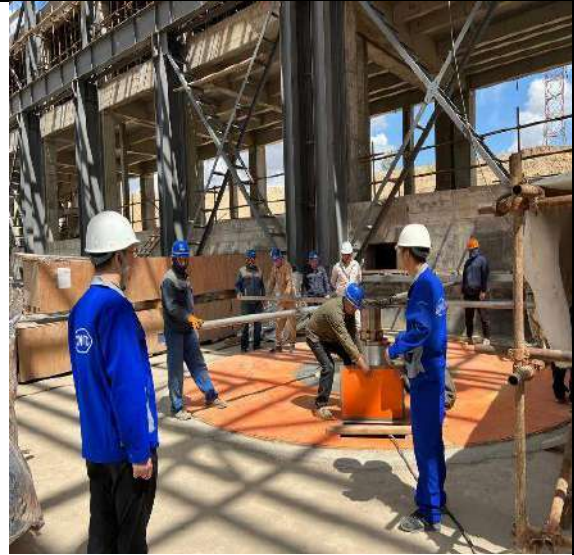
8. Workers not wearing gloves
